# Technical Service Bulletin

SUBJECT:  <b>Ring terminals do not lay flat on Tesla 90° adapters</b>	NUMBER: TSB-24-001
	DATE: April, 2024
	PRODUCT: 90° adapters for Tesla modules

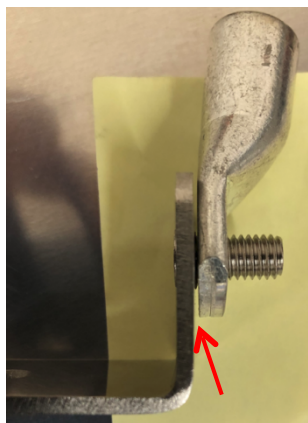
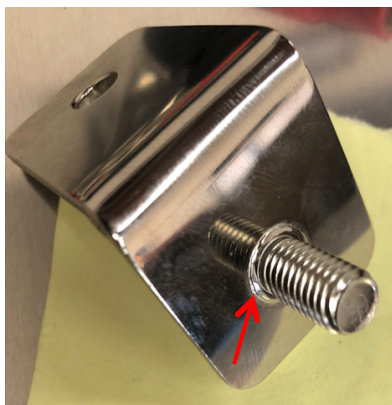
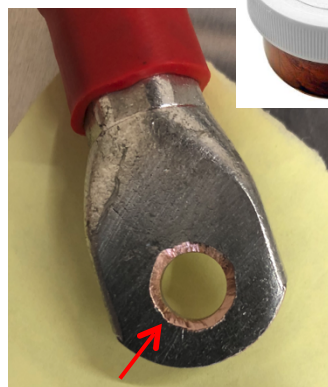
Some affected 90° adapters for the Tesla modules have a raised edge at the stud preventing a good flat surface to the cable ring terminal.

Inspect for clearance between bus bar and terminal. If there is any gap at all, use a countersink drill bit to remove just enough until there is no gap. Apply Wurth copper terminal paste to the machined area and flat mating surfaces.
